DEPARTMENT OF TRANSPORTATION

Contract #: 04-0120F4Cty: SF/ALA Rte: 80 PM: 13.2/13.9File #: 69.15**SOURCE INSPECTION REPORT****Resident Engineer:** Pursell, Gary**Address:** 333 Burma Road**City:** Oakland, CA 94607**Report No:** SIR-000633**Date Inspected:** 24-May-2009**Project Name:** SAS Superstructure**OSM Arrival Time:** 0**Prime Contractor:** American Bridge/Fluor Enterprises, a JV**OSM Departure Time:** 12**Contractor:** Zhenhua Port Machinery Company, Ltd (ZPMC), Changxing Island**Location:** Changxing Dao, Shanghai

Other: Surface Preparation and Coatings Application**Bridge No:** 34-0006**Component:** OBG 1AAE, Lift 3 & 4**Bid Item:** 77,78,79,80**Lot No:** B226**Summary of Items Observed:**

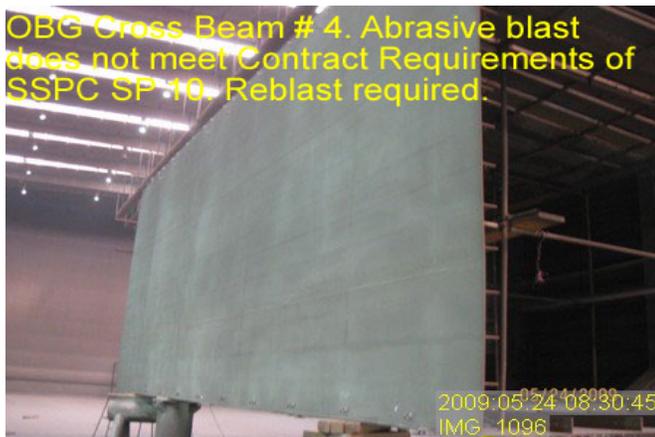
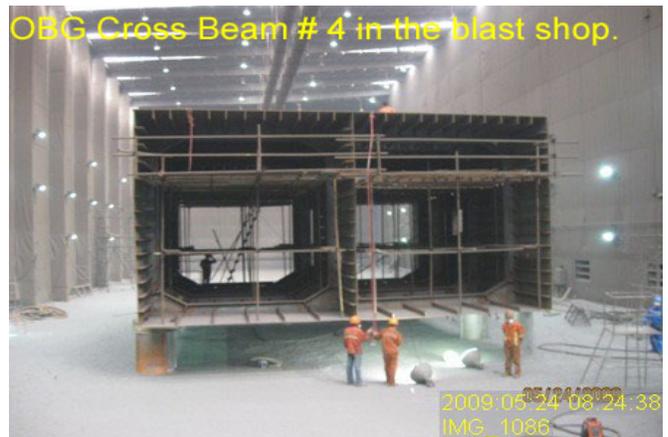
Caltrans QA Coatings Inspectors received a Notice of Inspection for to attend a joint inspection with ABF and ZPMC QC inspect external coating damaged area repairs on Lifts 3 and 4 East. The area was not ready for inspection. Several spots in the repair area was identified to be included in the repair. Mud-cracking was located and marked for re-blast. Grinding and abrasive blasting was resumed. The surface area was not cleaned prior to abrasive blasting to remove dirt, grime and stains.

Fabrication on assembled components of the OBG's and Towers are not complete. Outstanding weld repairs have not been performed. Coating damage requiring re-blast is expected.
